# Manhole Inspection Summary

Manhole # S39AA\_038MH

Insp Date: **12/12/07 7:45 AM**

**Location** Address: **aisquith st**

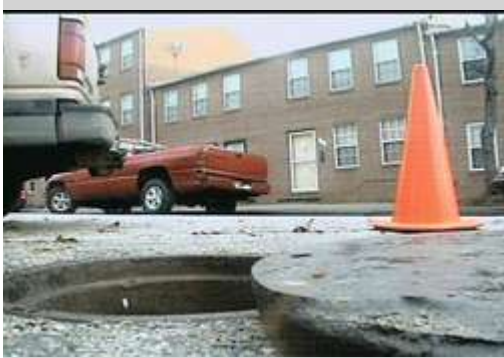
Defect 2

Condition: **Cracked**

Cracked cover

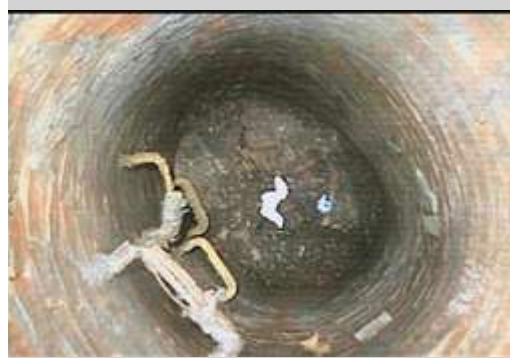
Defect 1

Condition: ☐ Sound ☐ Cracked ☐ Root Intrusion ☒ **Loose Brick** ☐ Deteriorated

Condition: ☐ Sound ☐ Cracked ☐ Root Intrusion ☐ Deteriorated ☐ Leaks ☒ **Debris**

Count: **4** Missing: **0** ☒ **Corroded**

☒ **Evidence Of Surcharge** Depth: **3.5** (ft.) ☐ Active Surcharge Present

Channel Debris, Corroded Steps,  
Surcharge Evidence, Loose Bricks in  
Corbel

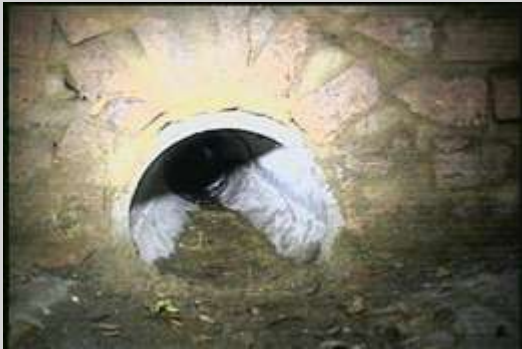
12 O'Clock Outflow

8 in. Circular Gravity Sewer  
Pipe Out @ 12 O'Clock

Deposits: ☐ None ☒ **Mud** ☐ Sludge ☐ Debris ☐ Grease

Silt Depth: 1 (in.) Deposits Extent: **Light**
